Request List for 111 Main St Hendersonville TN 37075

Roof Exterior

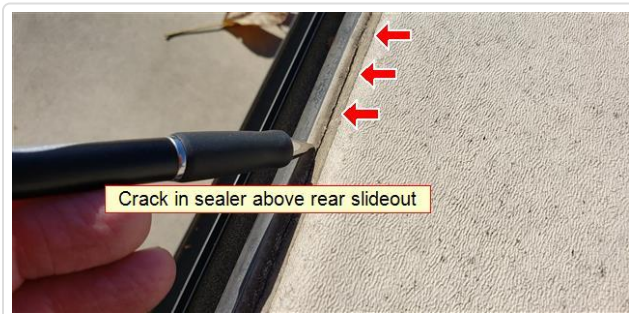
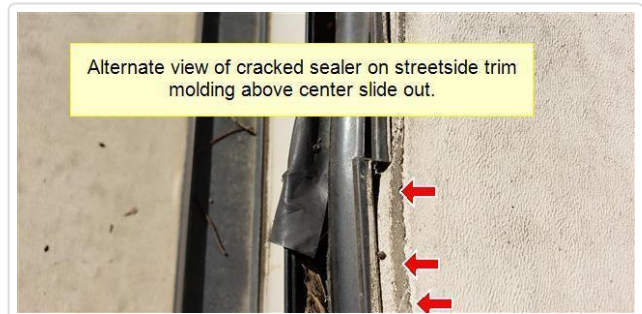
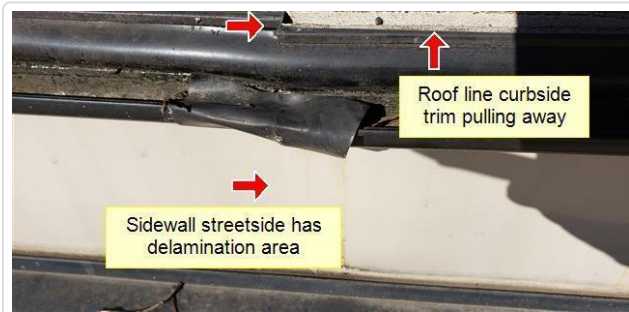
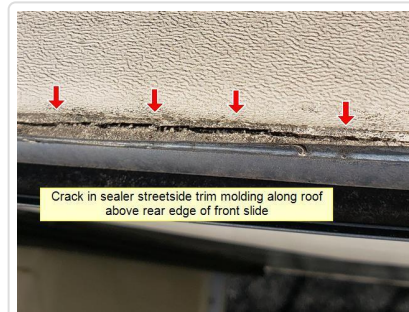
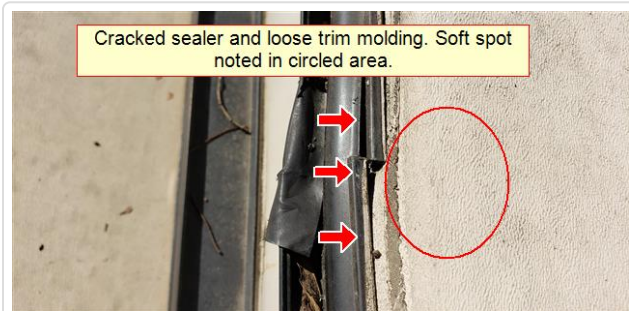
2. Trim Rail (Streetside)

- **Repair Requested**
Customer Comment
- **Inspector's Comment**
2.4 Most notable areas

1) Area above rear slide out.

2) Above center slide out. In this area a soft spot approximately 1/2" in diameter was found in decking under rubber roof just above center streetside slideout along this edge.

It is recommended to have these inspected by a qualified RV technician.

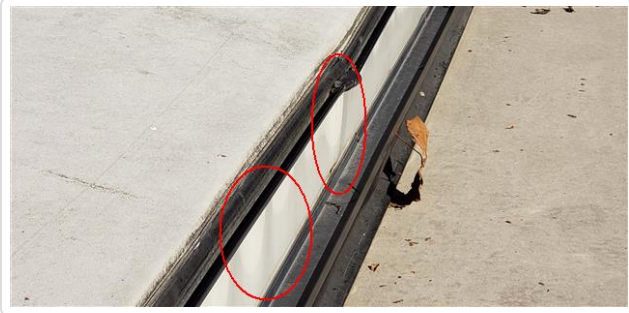
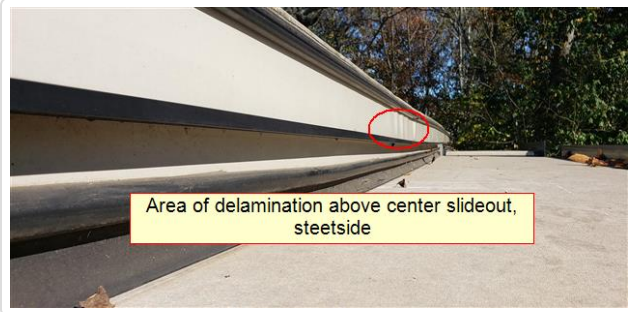
3. Sidewall Condition

streetside wall above center slide out.

- **Repair Requested**
Customer Comment
- **Inspector's Comment**
3.0 C Inspector noted an area of delamination above the center slide out approximately . It is recommended to have this inspected by a qualified RV technician.

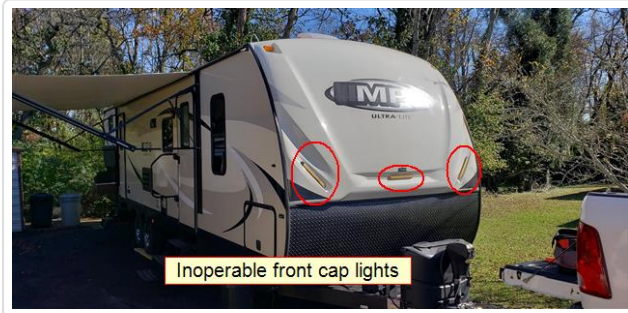
5. Front Clearance Lights

- Repair Requested
Customer Comment
- Inspector's Comment
10.2 Front cap lights inoperable, clearance lights function properly

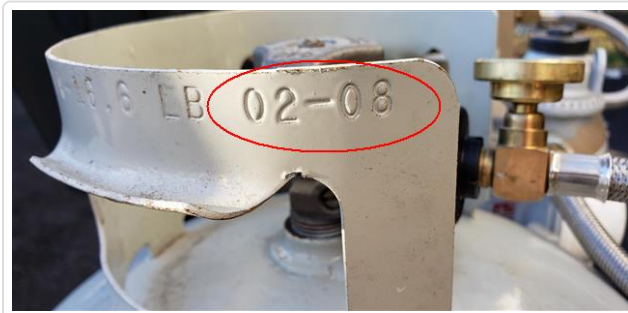
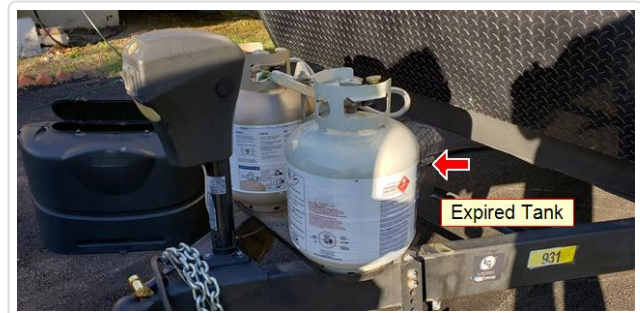
6. DOT Tank(s)

- Repair Requested
Customer Comment
- Inspector's Comment
13.0 Inspector noted the tank certification on the on the streetside tank is expired. It is recommended that this be checked by a qualified technician.

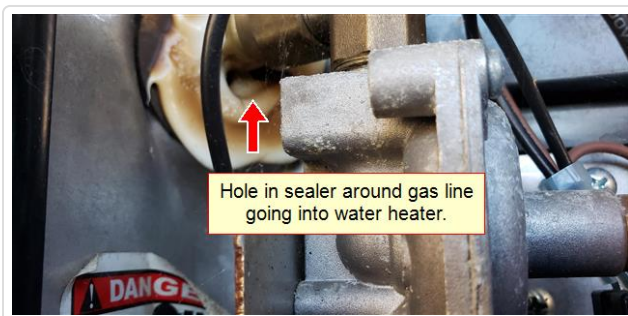
7. Water Heater - Rubber Grommet Around Gas Line Sealed

- Repair Requested
Customer Comment
- Inspector's Comment
15.1 A hole in the sealer around the propane line feeding the water heater was noted. It is recommended to have this inspected by a qualified technician.
